## **CMC Bozeman Facility Supplemental Investigation Report**

**City of Bozeman**

Tetra Tech Project No. 1157720035.200

January 6, 2009

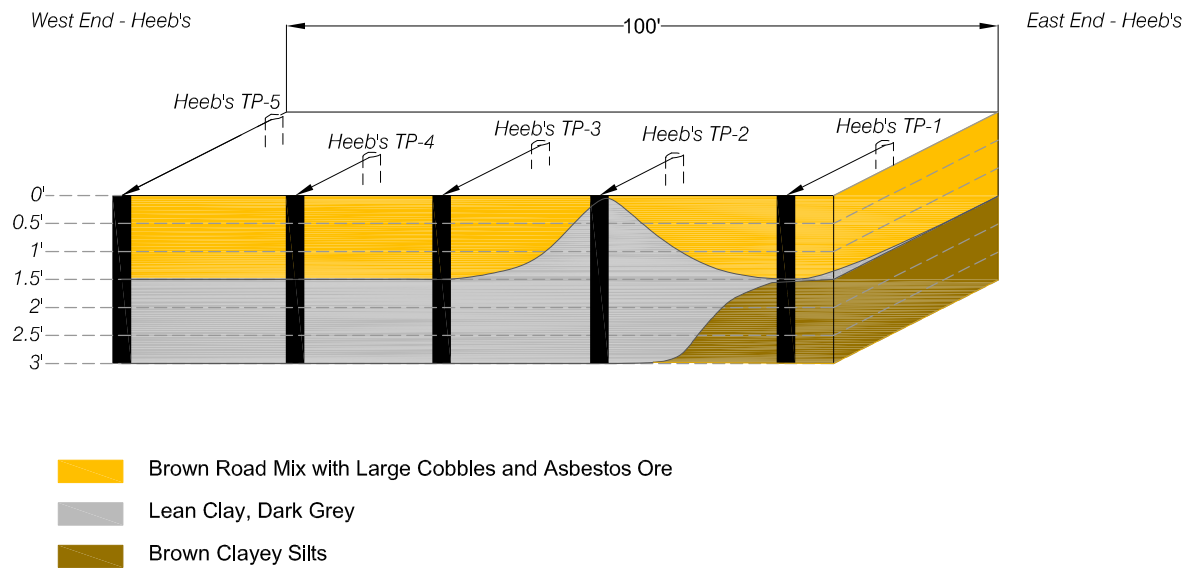
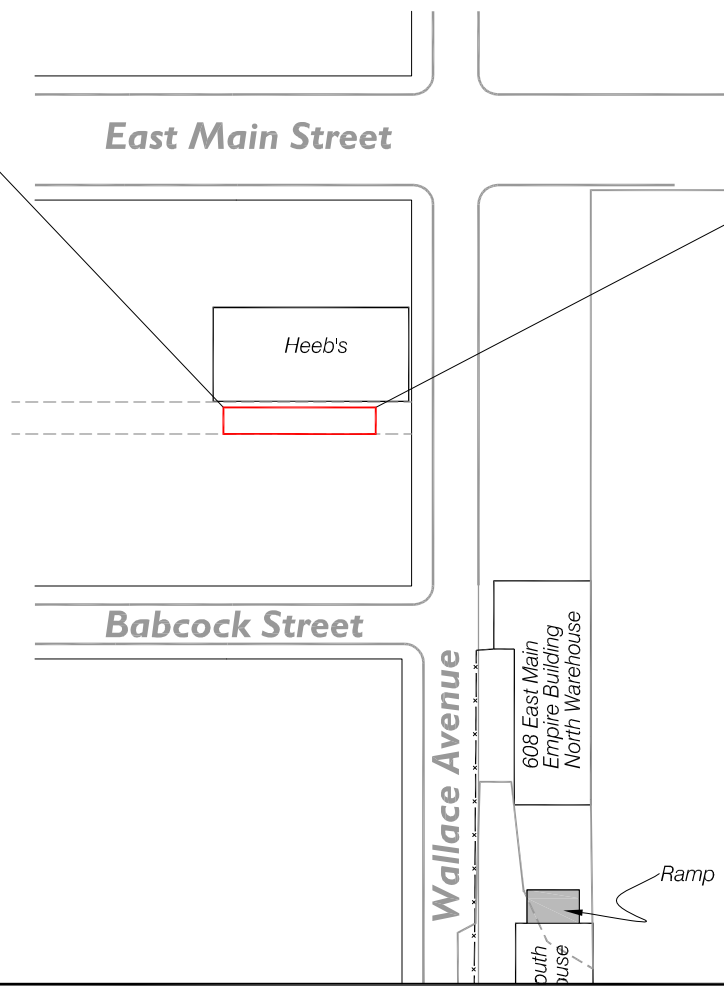
Heeb's - Test Pit Diagram  
CMC Bozeman Facility  
Bozeman, Montana  
FIGURE 7

Tetra Tech collected samples from the following five test pits: Heeb's TP-1, Heeb's TP-2, Heeb's TP-3, Heeb's TP-4, and Heeb's TP-5. Samples were collected from the base of each test pit down to the 3-foot minimum test pit depth. A cross-section summarizing the test pit findings is shown on **Figure 7**. Tetra Tech estimates the actual volume of asbestos contaminated soil is 123 yd<sup>3</sup>, however we estimate 227 yd<sup>3</sup> of soil will need to be removed due to over-excavation and the likelihood of discovering asbestos not encountered by the test pits. With an estimated volume of 227 yd<sup>3</sup>, and assuming a 30 percent contingency, this equates to approximately 295 yd<sup>3</sup> of asbestos to be removed. Tetra Tech's calculations are included in Appendix G.

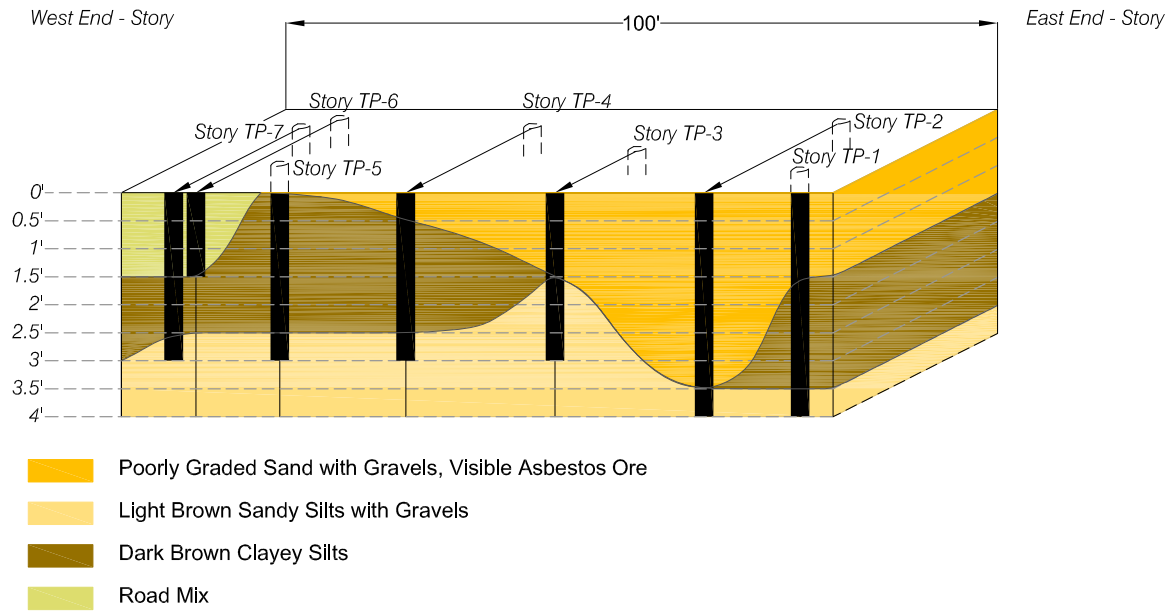
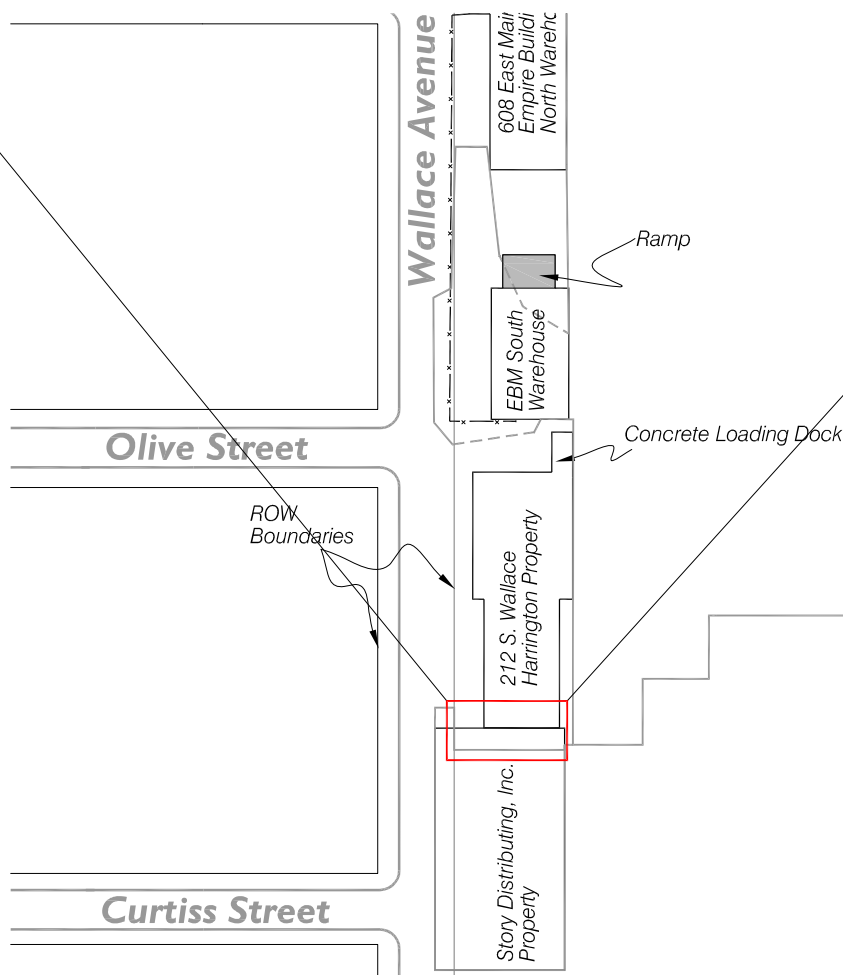
Story - Test Pit Diagram  
CMC Bozeman Facility  
Bozeman, Montana  
FIGURE 8

The Story Distributing property was assessed on December 28, 2007. The assessed area consisted of an approximately 100-foot wide by 15-foot long area of soil along the exterior concrete foundation/footing wall 15 ft south of the SHB (**Figure 8**). This SI area adjoined the

previously assessed area on the City library property. The visual assessment indicated the presence of asbestos from depths of 0.0-feet to 3.5-feet in the seven test pits in this assessment area as shown on test pits logs and photographs in Appendices E and F, respectively. The location for each test pit is presented on the logs with respect to existing structures. Tetra Tech collected samples from the following six test pits: Story TP-1, Story TP-2, Story TP-3, Story TP-4, Story TP-5, and Story TP-7; Tetra Tech did not collect additional soil samples from Story TP-6 as this test pit only contained engineered 1½-inch minus road base material due to this location's former documented excavation (RTI, 2004). Test pit logs additionally document soil classifications and depths at which native soil was encountered. Only test pits Story TP-1 through Story TP-3 were documented as containing visible asbestos. No visible asbestos was noted on the surface at the time of sampling. A cross-section summarizing the test pit findings of this area along with native soil depths is shown on **Figure 8**.

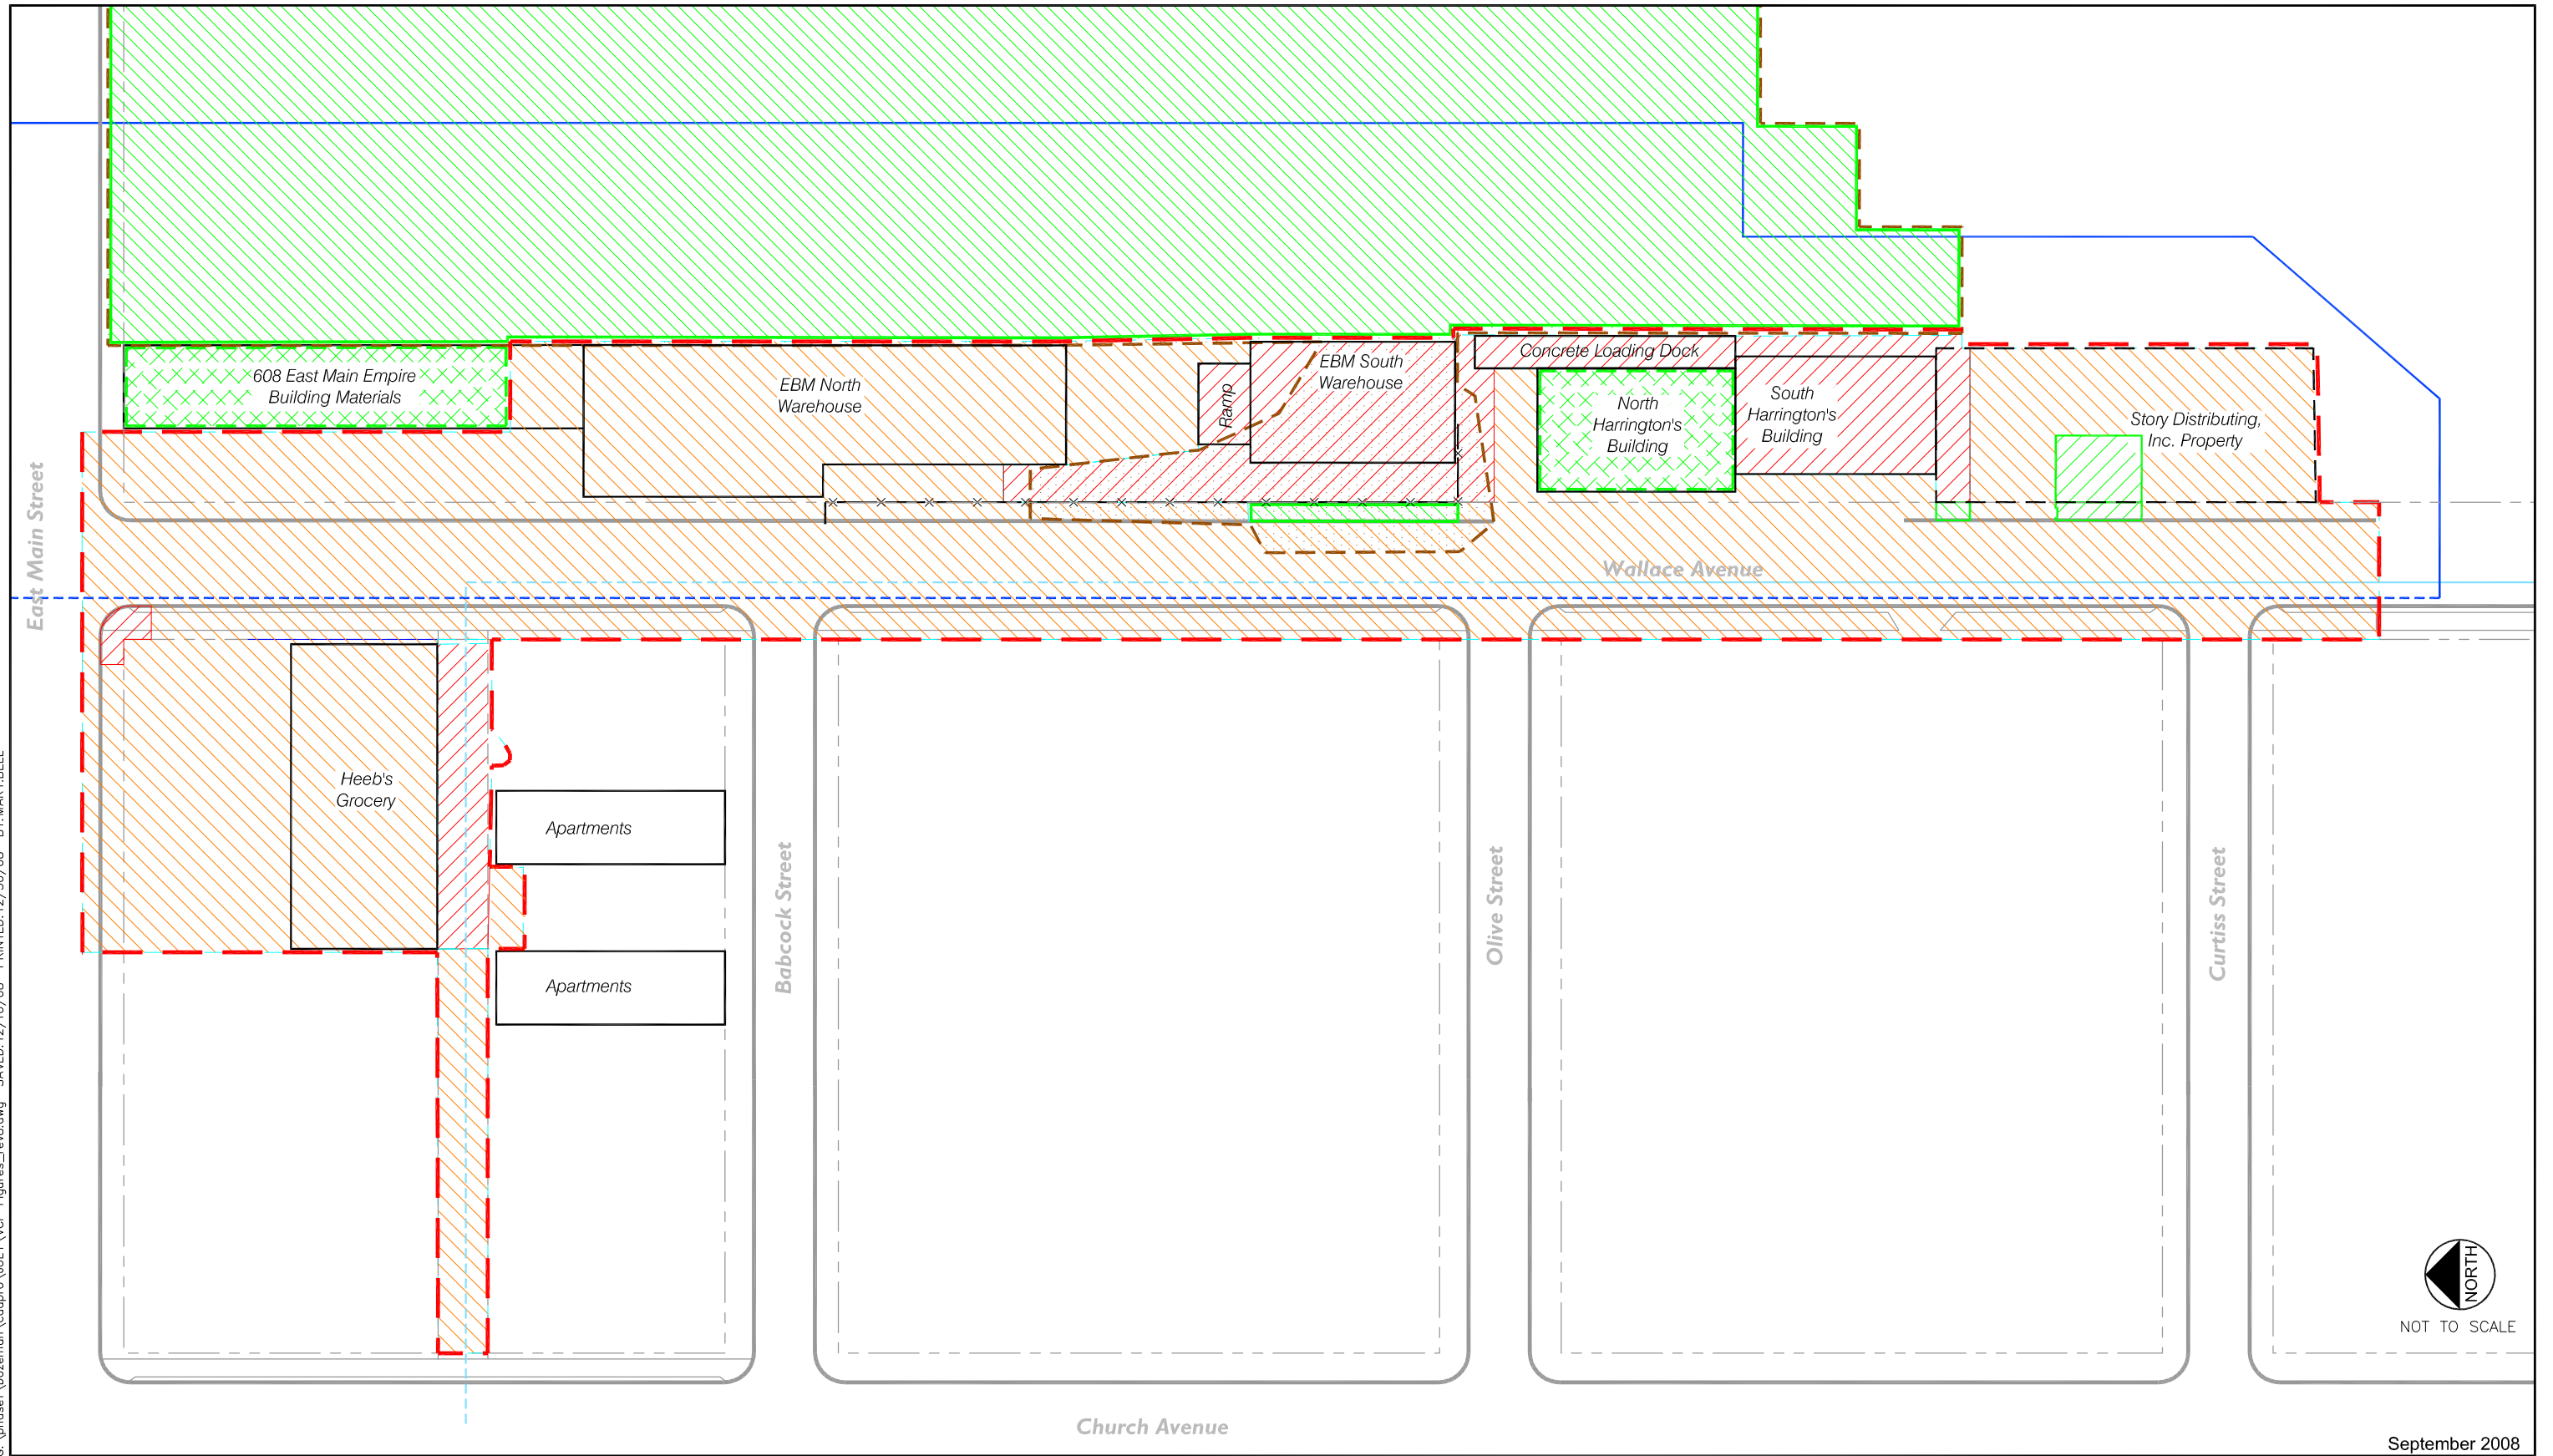
Observed & Potential Asbestos Ore  
CMC Bozeman Facility  
Bozeman, Montana  
FIGURE 9

Based upon the findings of the soil sampling program on the South Harrington Building, Heeb's and Story Distributing properties, we have identified areas where asbestos has either been observed or may potentially exist. These areas are outlined on **Figure 9**. These areas were identified based upon evaluation of soil sample results and observations collected to date by this and previous investigations at the Facility.

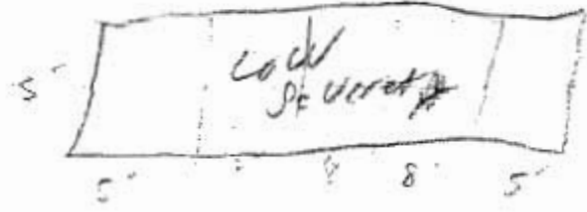
- ✓ Section Side walk @ ally - 15' - 0" wide - Exposure Agg - NOT low or deformed
- ✗ Entrance gate @ ally 5' x 15' Exposure Agg. NOT deformed - 2" - 3" Crack 5' long at center of slab med. severity
- Side walk @ E. end of Hatch 11' - 4" wide x 60' long
